# Airfield Research Group Ltd

## ARG Research Note No.27: RAF Alconbury - A Record Survey of the Hush House and Control Tower

Paul Francis and Paul Bellamy – July 2015

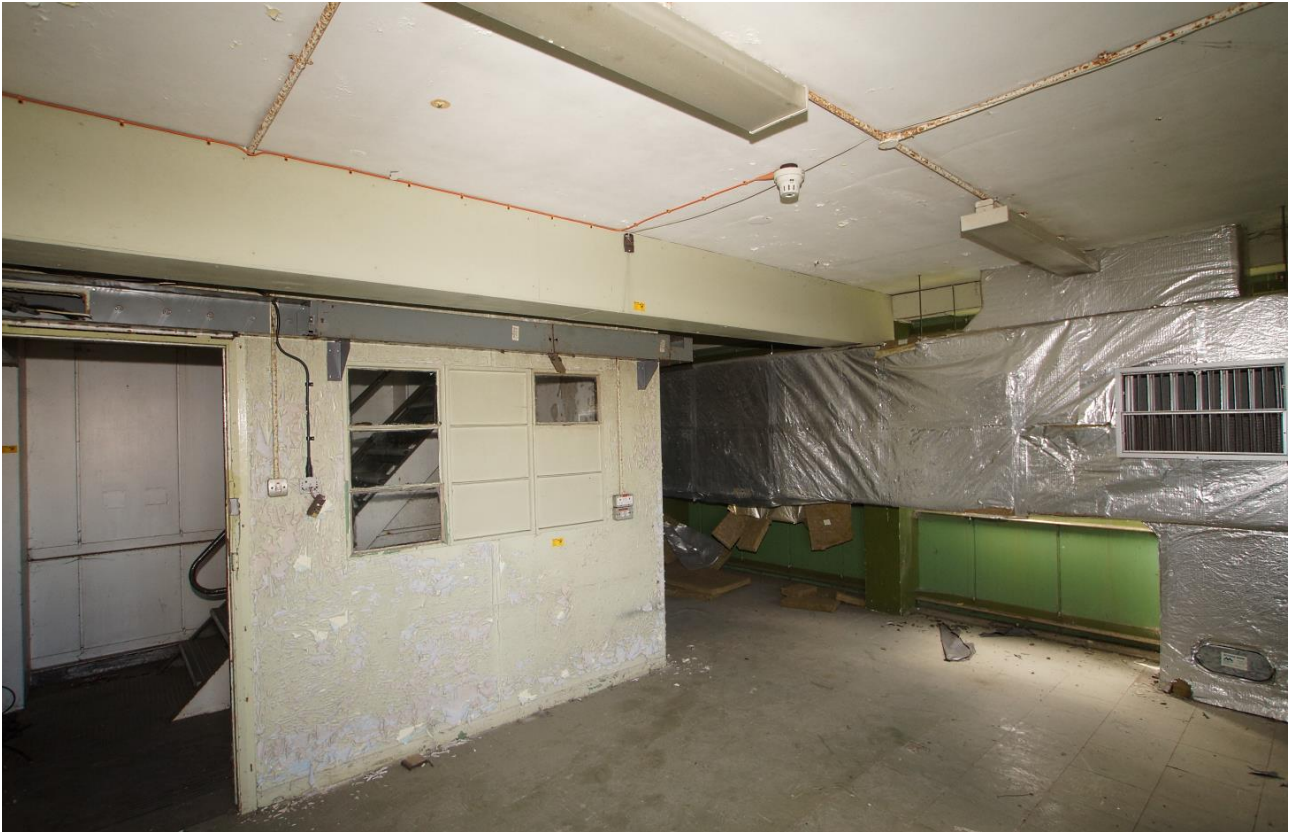
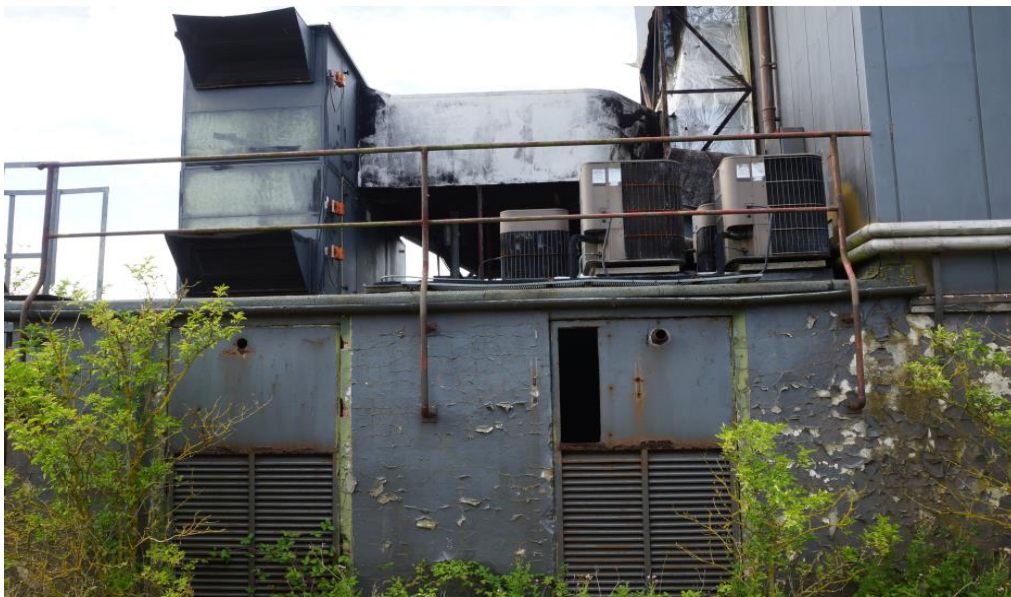
The original function of the first floor is unknown, it was an open plan room with railings around an open stir well. In 1975, it became the machine room and contained part of the ventilation plenum chamber, the remaining half being erected above the roof of the generator house. There was originally a pair of metal windows set into timber frames on the north elevation but after 1975, these were replaced with four port holes along with new external cladding. The partition with the borrowed light seen in the photo, was added before 1975.

Plates 48 & 49: Two views showing ventilation plant at first floor level (Blg.90)

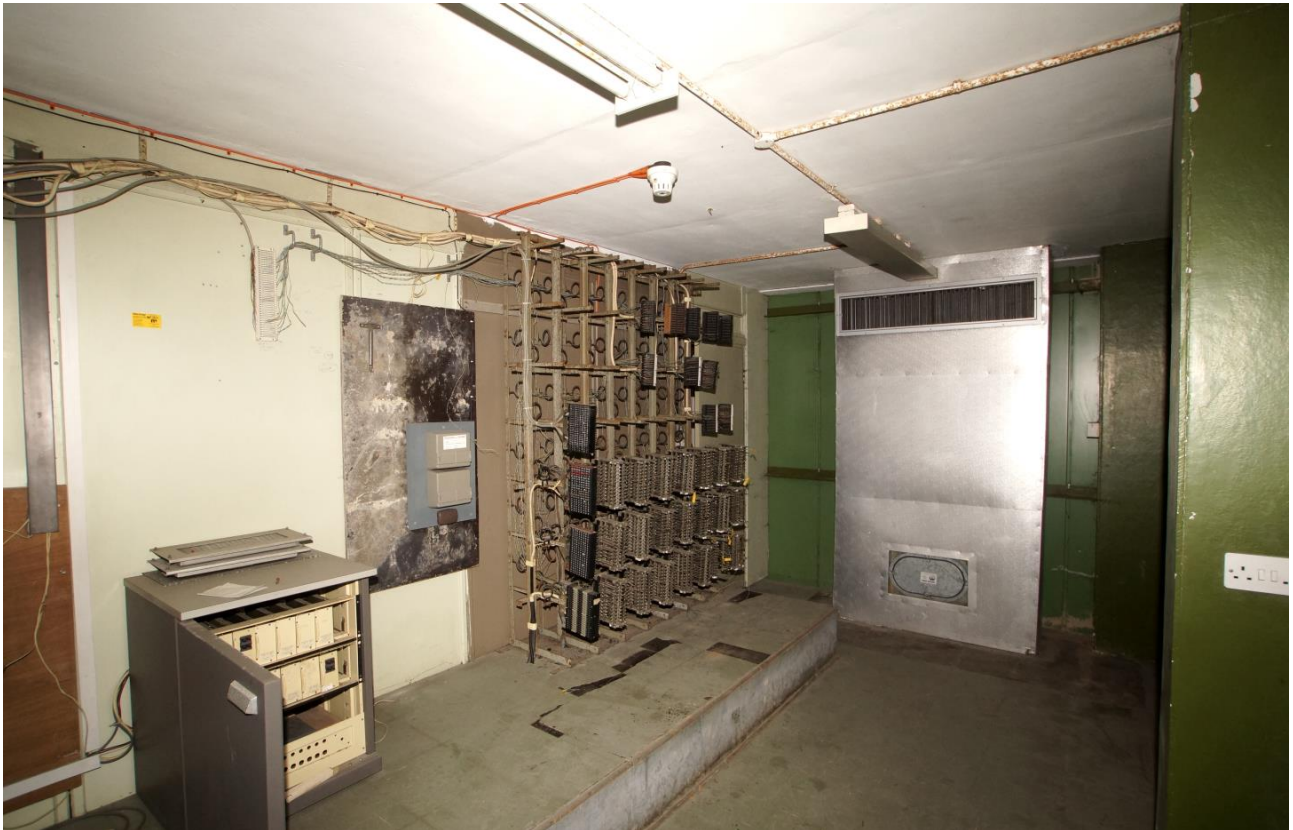
Plate 50: Second floor (Blg.90)

This floor was divided into two equal unequal halves by Uni-Seco partitions into the stair well and landing forming one, the other half being the original ventilation plant room, the air intake for this being on the west wall. Around 1975, this plant was removed and it became the telephone exchange.

The north elevation originally had a pair of steel windows set into timber frames. Apart from the external cladding, this room remains as-built.

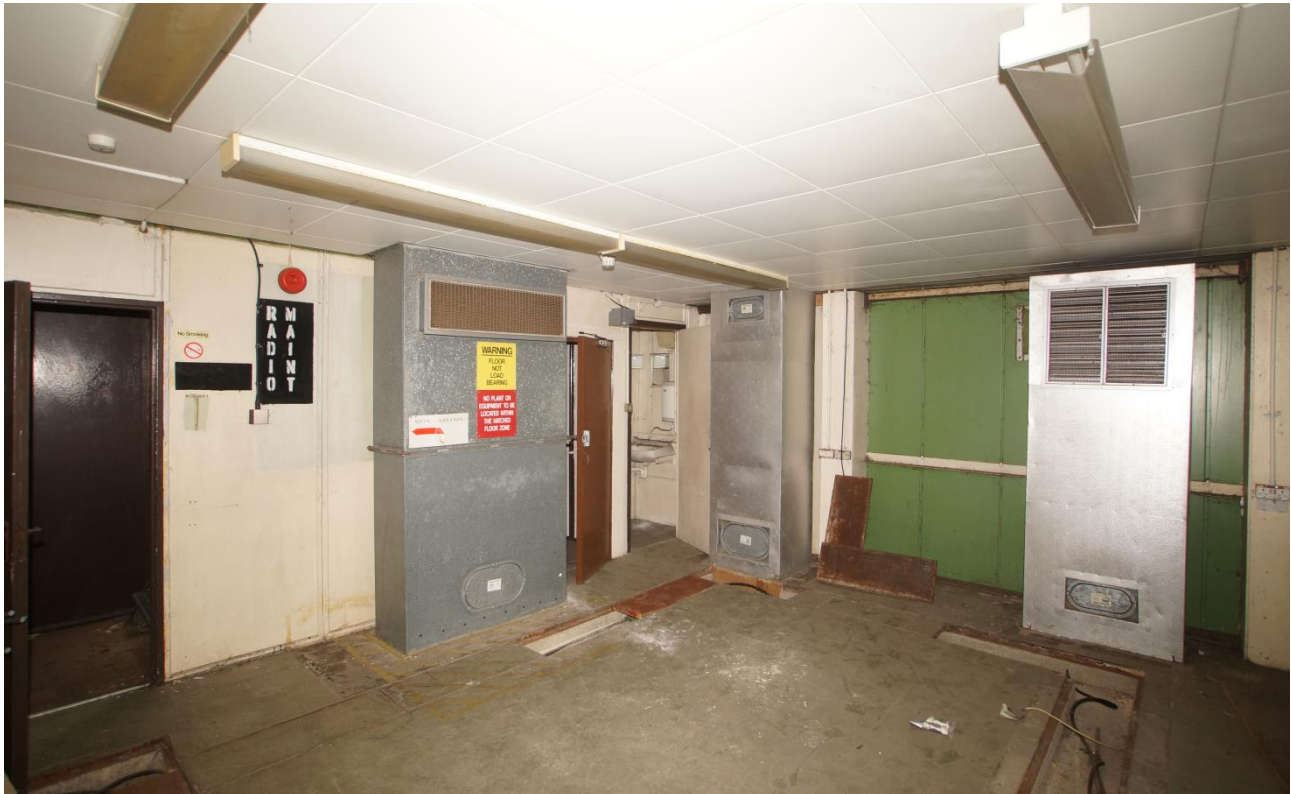
Plate 51: Third floor (Blg.90)

This floor was the equipment and junction room and in support of this the floor slab is twice as thick as other floors partly to incorporate a 4in deep electric cable ducting with heavy steel covers.

There is also a small toilet as well as the stairwell which on this floor only was originally encased in Uni-Seco partitions. All walls were lined with acoustic tiles, the north elevation originally had the same window arrangement as the lower floors, plus another one on the west and east elevations. There was also a small balcony on the south elevation with access from a moveable wall panel but this was removed in 1975.

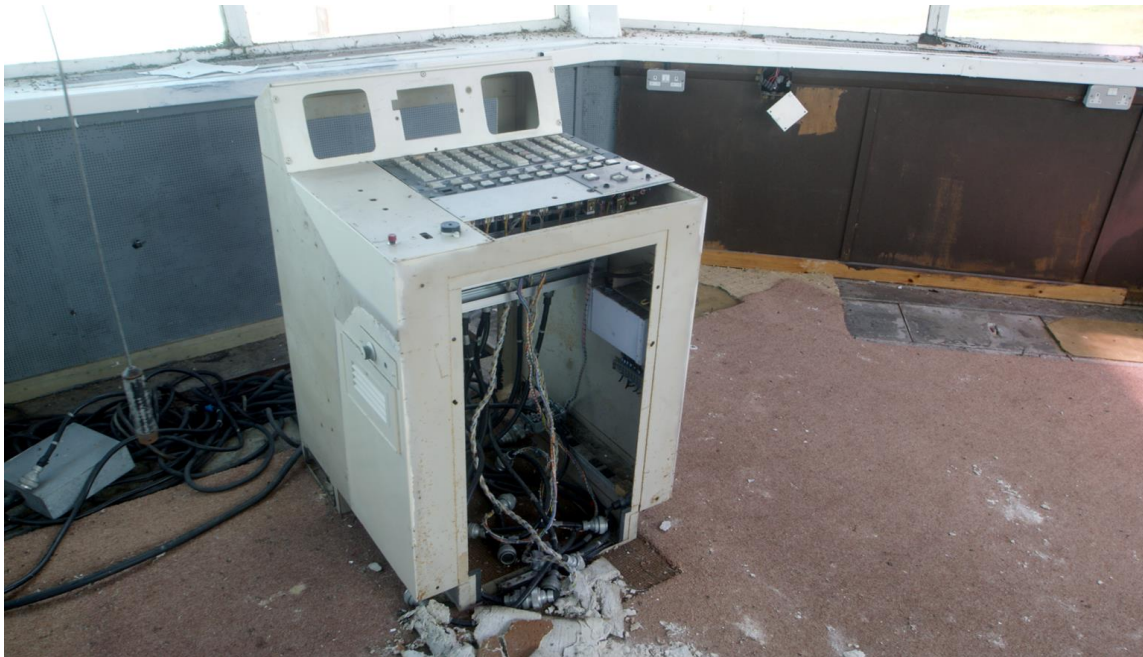
Plate 52: Part of the runway lighting control panel – as seen in 2010

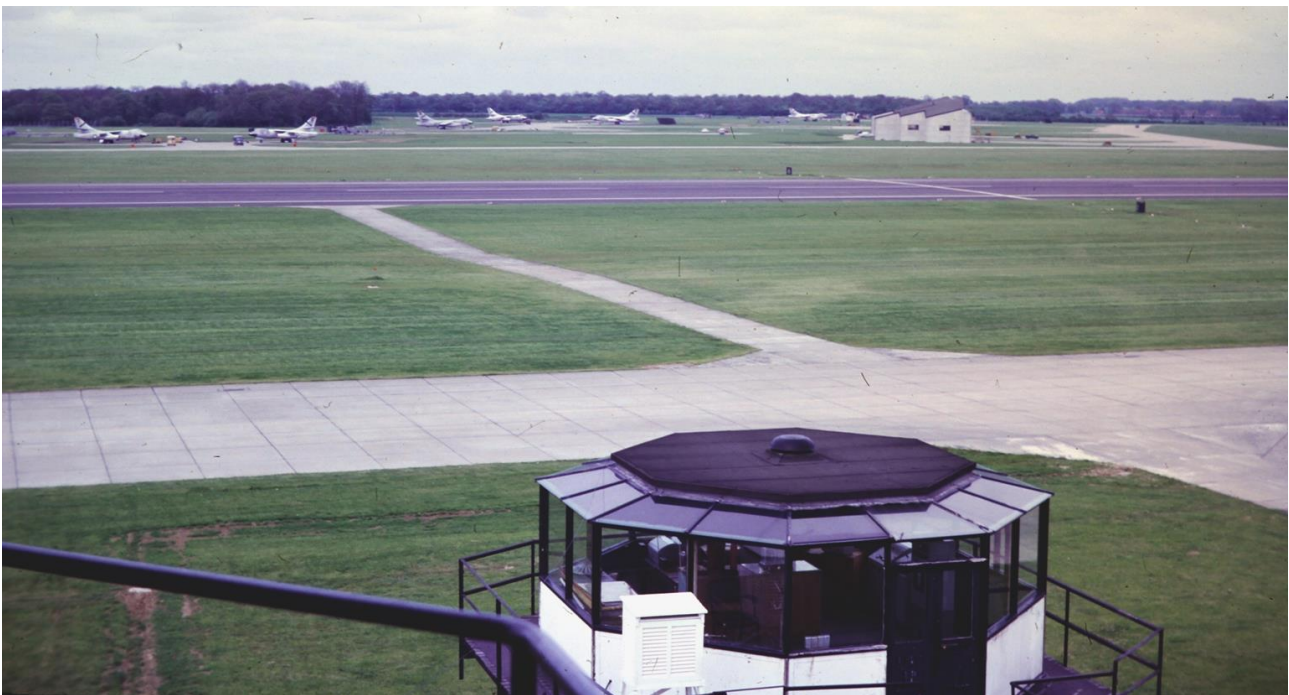
A second tower was erected c.1956 to Drawing LET/ALC/1979, called a weather tower it was positioned where the present building 89 is located, which was actually inside the steel framework of the tower. It was constructed of 3in by 7in stanchions braced with 2in angle iron. It carried the cabin and a balcony constructed of timber and boarding at a height of 17ft. The cabin was steel framed clad with Uni-Sco panels and timber glazed windows, the roof was partly asbestos sheeting and glazing panels fixed to the framework. It survived to at least 1977. Note that an earlier tower may have been erected for a short period at the opposite end of building 86.

Plate 57: Weather Observation tower 1964 (Blg.91). Photo: Barry Smith

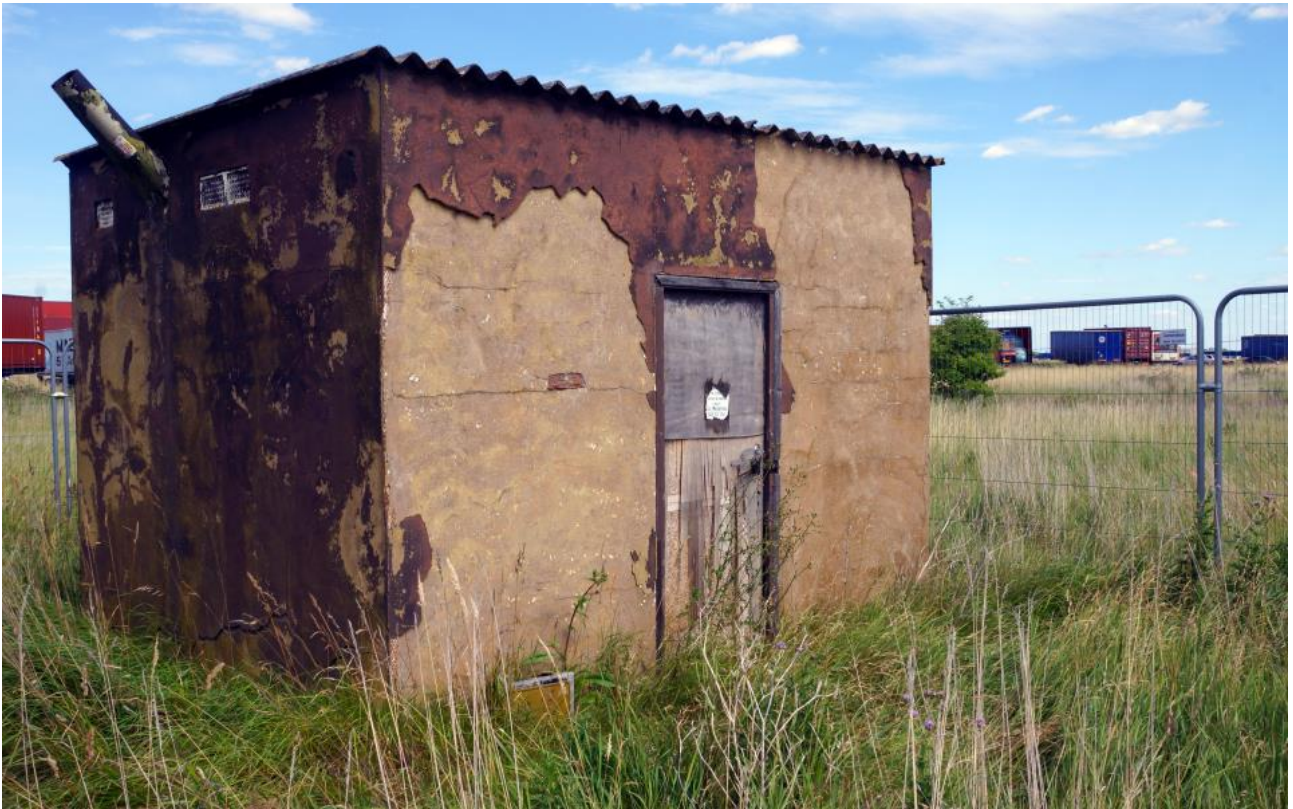
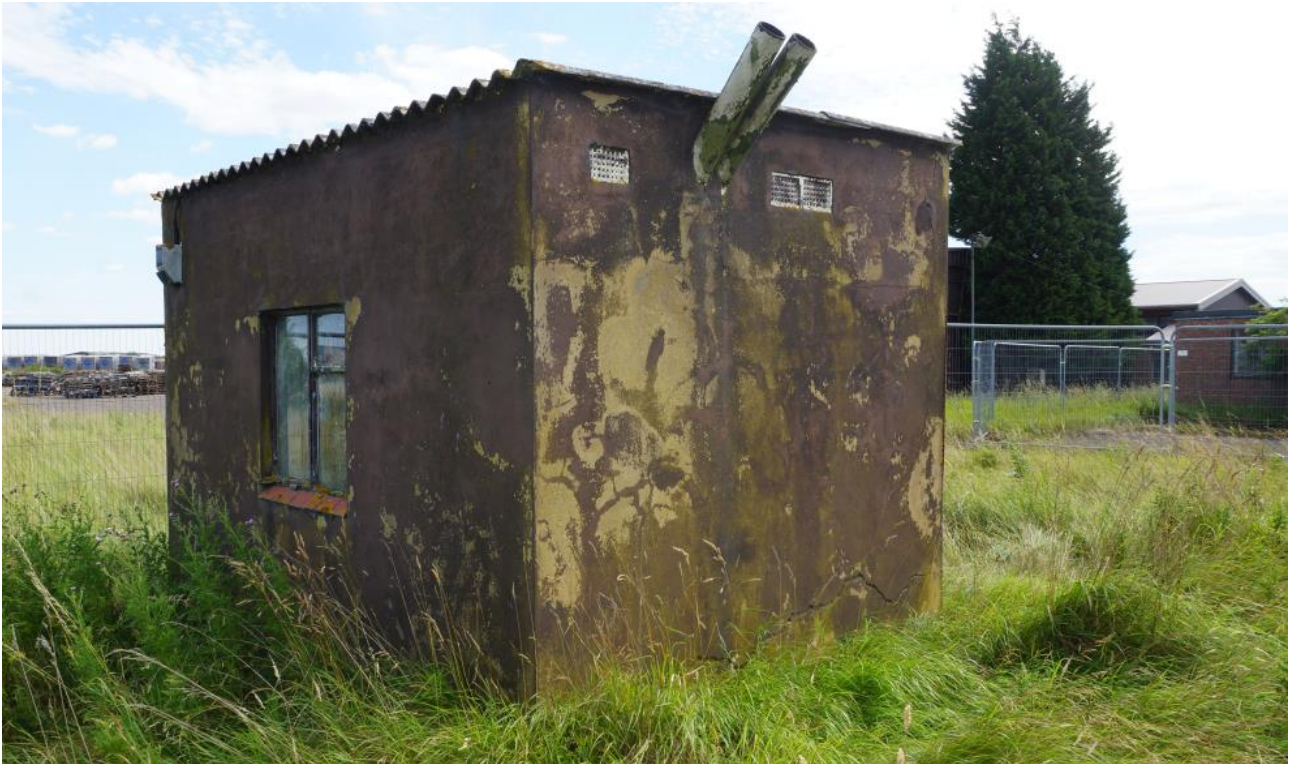
The 'B' centre was also built c.1956, it is a small windowless and cement rendered temporary brick built building with internal piers and a single metal casement window in the north elevation. There are a pair of high level vents, one each on the east and west elevations, only one door which is located in the south elevation. It has a single pitch roof of asbestos sheeting.

'B' centres convert signals from the selected commands from the 'A' centre in the control tower to switch half of the lighting on the instrument runway. There would therefore have been two 'B' centres, the other somewhere to the east of this one.

Plates 58 & 59: 'B' centre (Blg.89)
